9 Preservation Briefs

Technical Preservation Services
National Park Service
U.S. Department of the Interior

The Repair of Historic Wooden Windows

John H. Myers

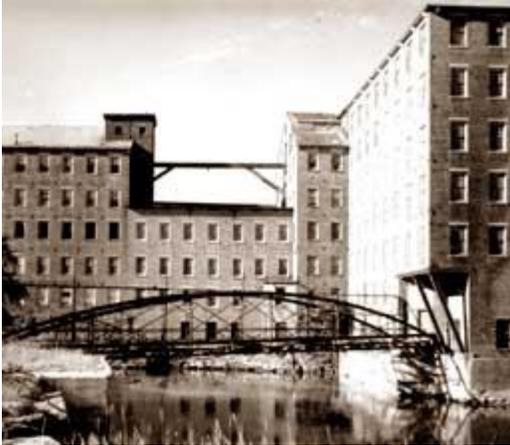
Windows are frequently important visual focal points, especially on simple facades such as this mill building. Replacement of the multi-pane windows with larger panes could dramatically alter the appearance of the building. Photo: NPS files.

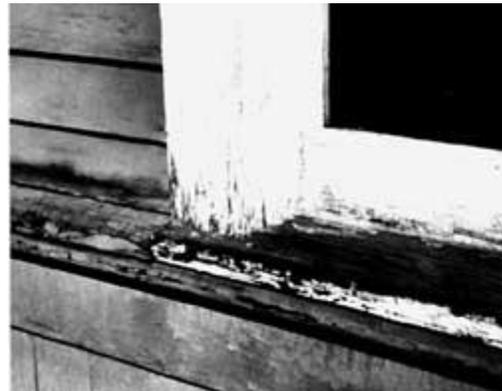
Deterioration of poorly maintained windows usually begins on horizontal surfaces and at joints, where water can collect and saturate the wood. Photo: NPS files.

Each window should be examined for operational soundness beginning with the lower portions of the frame and sash. Exterior rainwater and interior condensation can flow downward along the window, entering and collecting at points where the flow is blocked. The sill, joints between the sill and jamb, corners of the bottom rails and muntin joints are typical points where water collects and deterioration begins. The operation of the window (continuous opening and closing over the years and seasonal temperature changes) weakens the joints, causing movement and slight separation. This process makes the joints more vulnerable to water which is readily absorbed into the endgrain of the wood. If severe deterioration exists in these areas, it will usually be apparent on visual inspection, but other less severely deteriorated areas of the wood may be tested by two traditional methods using a small ice pick.

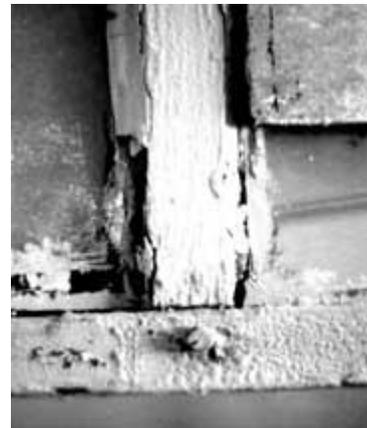
This historic double-hung window has many layers of paint, some cracked and missing putty, slight separation at the joints, broken sash cords, and one cracked pane. Photo: NPS files.

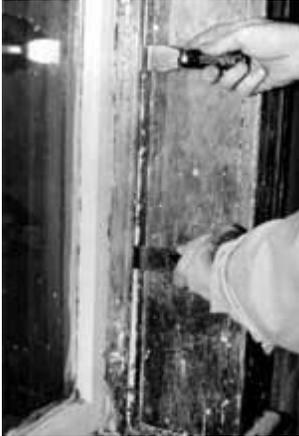
After removing paint from the seam between the interior stop and the jamb, the stop can be pried out and gradually worked loose using a pair of putty knives as shown. Photo: NPS files.

Paint removal should begin on the interior frames, being careful to remove the paint from the interior stop and the parting bead, particularly along the seam where these stops meet the jamb. This can be accomplished by running a utility knife along the length of the seam, breaking the paint bond. It will then be much easier to remove the stop, the parting bead and the sash. The interior stop may be initially loosened from the sash side to avoid visible scarring of the wood and then gradually pried loose using a pair of putty knives, working up and down the stop in small increments. With the stop removed, the lower or interior sash may be withdrawn. The sash cords should be detached from the sides of the sash and their ends may be pinned with a nail or tied in a knot to prevent them from falling into the weight pocket.

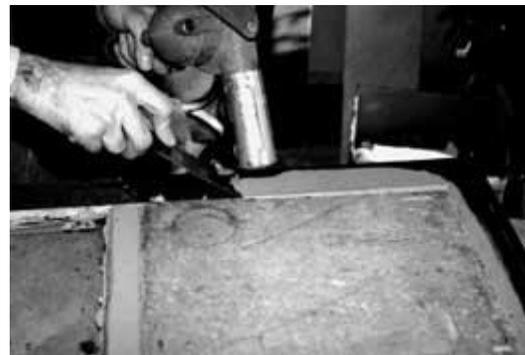
Sash can be removed and repaired in a convenient work area. Paint is being removed from this sash with a hot air gun. Photo: NPS files.

The sash can be stripped of paint using appropriate techniques, but if any heat treatment is used, the glass should be removed or protected from the sudden temperature change which can cause breakage. An overlay of aluminum foil on gypsum board or asbestos can protect the glass from such rapid temperature change. It is

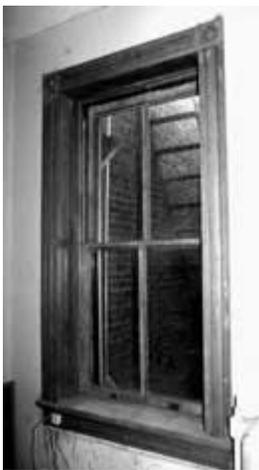
Following the relatively simple repairs, the window is weathertight, like new in appearance, and

serviceable for many years to come. Photo: NPS files.

The operations just discussed summarize the efforts necessary to restore a window with minor deterioration to "like new" condition. The techniques can be applied by an unskilled person with minimal training and experience. To demonstrate the practicality of this approach, and photograph it, a Technical Preservation Services staff member repaired a wooden double-hung, two over two window which had been in service over ninety years. The wood was structurally sound but the window had one broken pane, many layers of paint, broken sash cords and inadequate, worn-out weatherstripping. The staff member found that the frame could be stripped of paint and the sash removed quite easily. Paint, putty and glass removal required about one hour for each sash, and the reglazing of both sash was accomplished in about one hour. Weatherstripping of the sash and frame, replacement of the sash cords and reinstallation of the sash, parting bead, and stop required an hour and a half. These times refer only to individual operations; the entire process took several days due to the drying and curing times for putty, primer, and paint, work on other window units could have been in progress during these lag times.

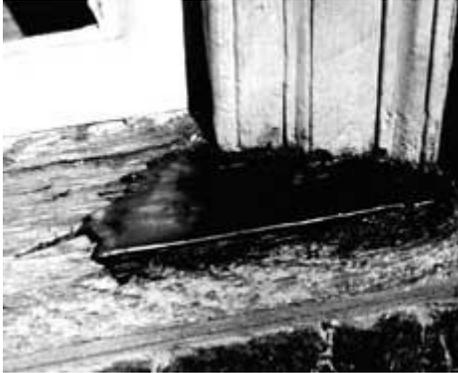
This illustrates a two-part epoxy patching compound used to fill the surface of a weathered sill and rebuild the missing edge. When the epoxy cures, it can be sanded smooth and painted to achieve a durable and waterproof repair. Photo: NPS files.

Wood may also be strengthened and stabilized by consolidation, using semirigid epoxies which saturate the porous decayed wood and then harden. The surface of the consolidated wood can then be filled with a semirigid epoxy patching compound, sanded and painted. Epoxy patching compounds can be used to build up missing sections or decayed ends of members. Profiles can be duplicated using hand molds, which are created
